Re: Former Roth Bros. Smelting Corp. Site 6223 Thompson Road, Dewitt, New York Consent Order C7-0001-94-10

Consent Order C7-0001-94-10
2011 Annual Asphalt Cap Inspection

Re: CAMU Cover Repairs

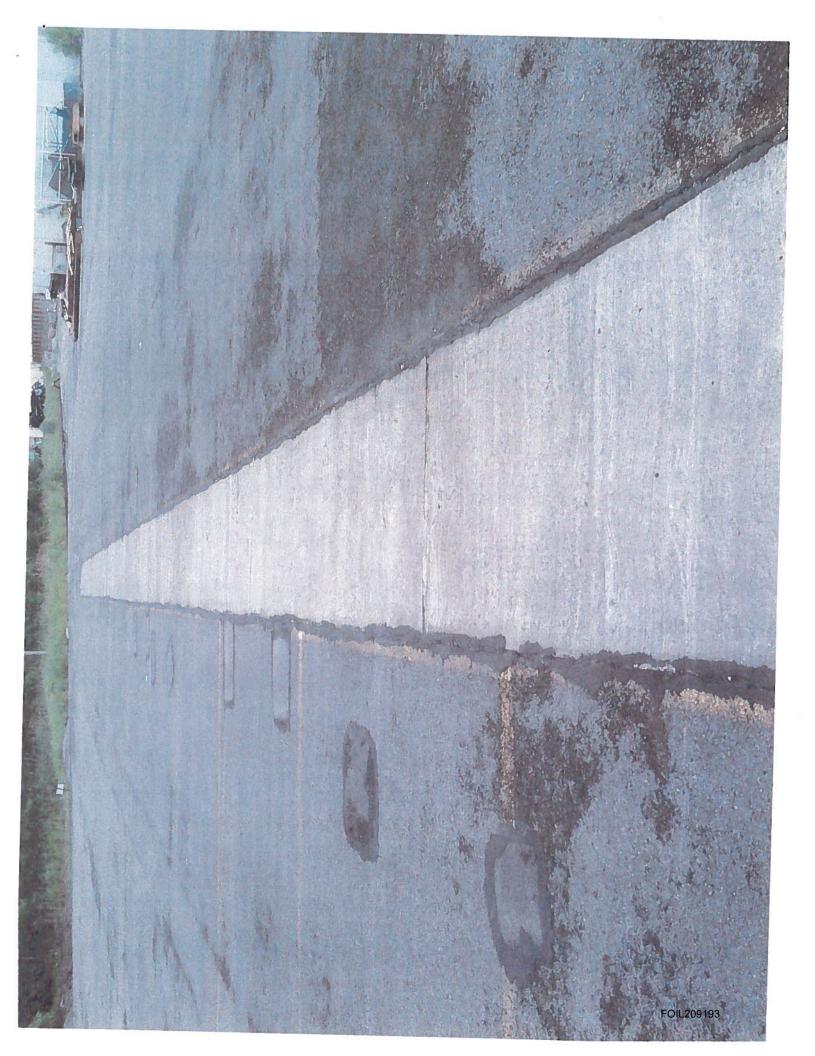
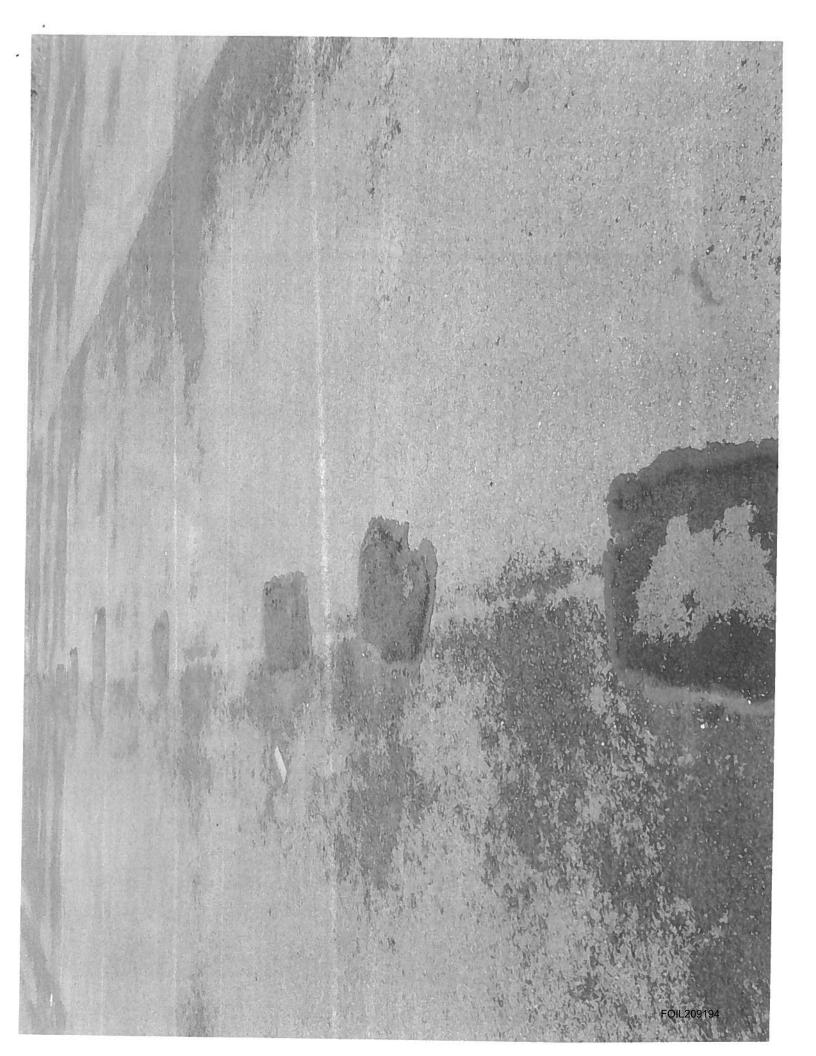
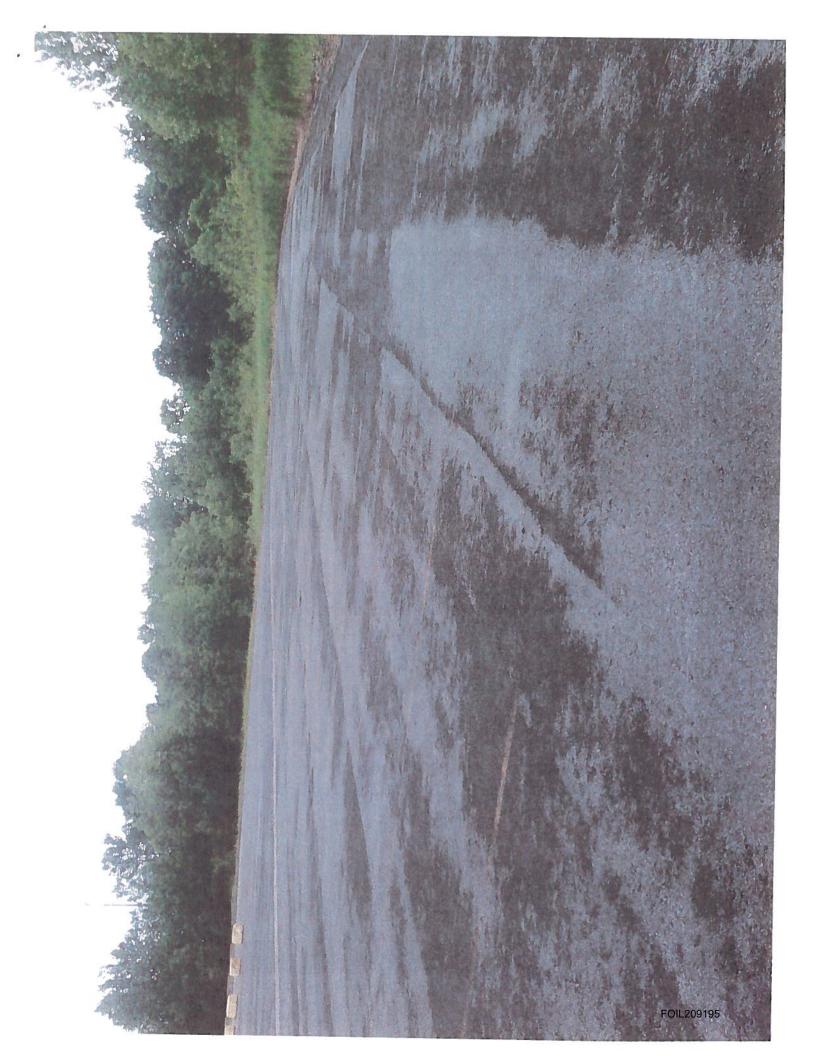
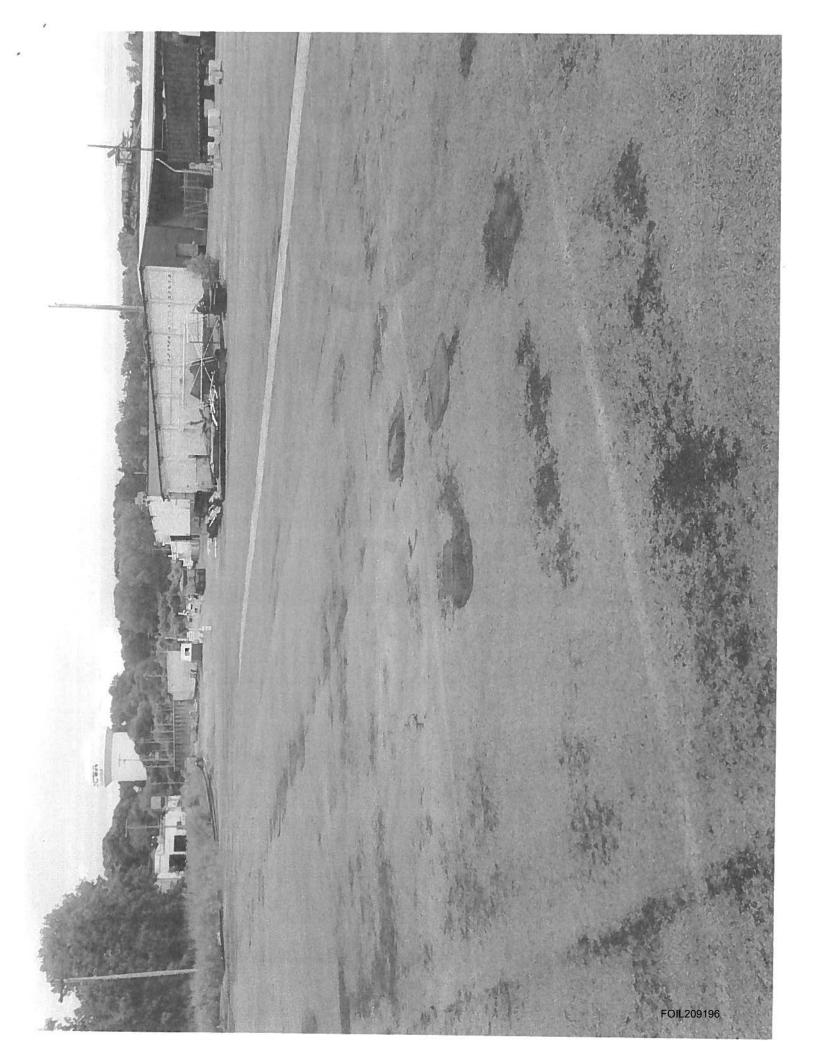
The asphalt cap had some minor areas in need of repair and a few noted areas of vegetation growth along the joint between the concrete dolly apron and the asphalt. Vegetation was also observed growing along the eastern side slope but not directly on the CAMU asphalt cap. All of the vegetation was treated with a non-selective herbicide (Round-Up) then the entire area was power swept. As done previously, the asphalt repair areas were filled with a hot asphalt mix and the repair edges were sealed.

I have completed the inspection of the asphalt cover on the CAMU area. I have found a few areas where the existing asphalt patches need to be cracked sealed and a few spots of vegetation growing along the joint between the concrete dolly apron and asphalt pavement. Vegetation along the slopes of the pavement have been treated and are not entering the CAMU cap area.

Crack seal edges and existing asphalt patches.

Treat all vegetation with a non selective herbicide (Round-up).

All repairs were completed by June 24, 2011.
